Property Inspection Report

44444 Anywhere Avenue
Springfield, VA 22152

General Information

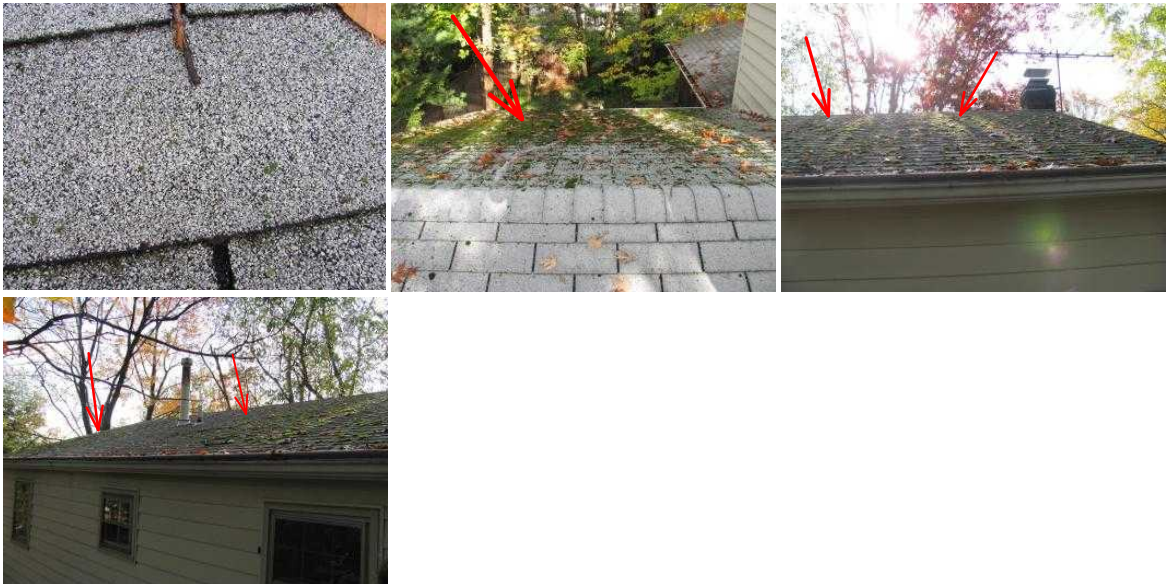
2. Material: Asphalt shingle - The roof shingles are worn and losing their granular surface.

The roof shingles on the rear shady side of the roof have a thick covering of green moss growing on the shingles.

The roof shingles are near the end of their useful service life, plan and budget for roof shingle replacement in the next 2 to 3 years.

Consider installing ridge vent and a larger roof mounted attic fan when replacing the roof shingles.

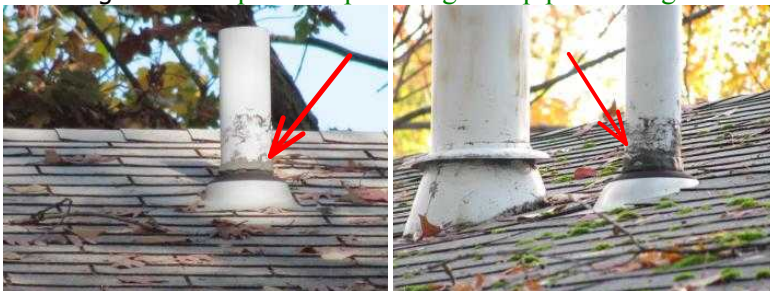
7. Plumbing Vents: Replace all plumbing vent pipe flashing when the roof shingles are replaced.

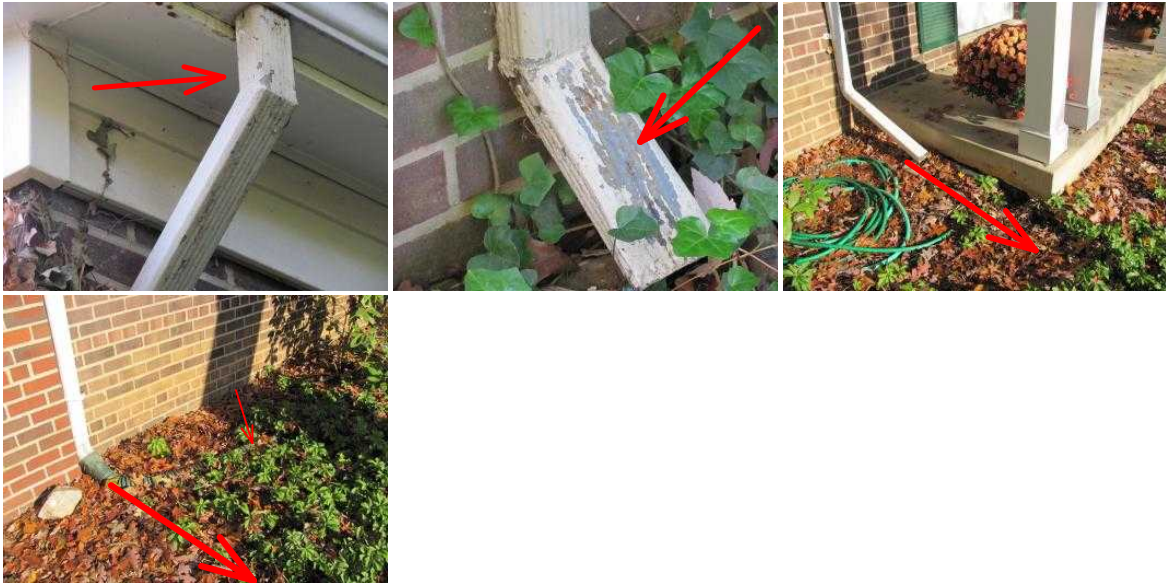
9. Downspouts: Aluminum, Galvanized - The lower roof gutters have some older galvanized downspouts that will need to be painted or replaced.

The front porch downspout needs to be extended to prevent roof water from draining into voids in the ground by the side of the front porch.

Extend front left downspout from the main roof at least 6 feet away from the house foundation.

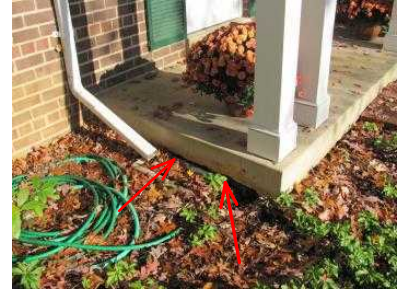
- F M NF NI
1. Driveway:
2. Walks: Stepping stones - The stepping stone walkway and the steps to the front porch are unevenly spaced and a trip hazard.
Recommend a wider, permanent walk way and steps all the same height to the porch.

3. Steps, Stoops: Replace the front steps to the entry porch, the steps should all be the same height.

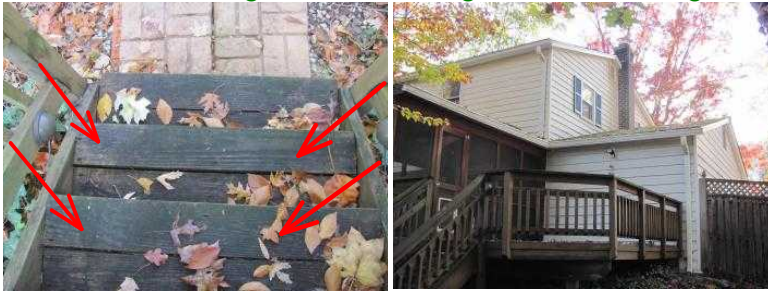
4. Porch: Rear screened porch - Recommend sealing the floor of the screen porch.
5. Deck: Pressure Treated wood - The rear deck stairs to the back yard have a loose stair tread near the ground level, this is a trip hazard.

Recommend cleaning the wood decking boards and sealing or staining the all wood surfaces.

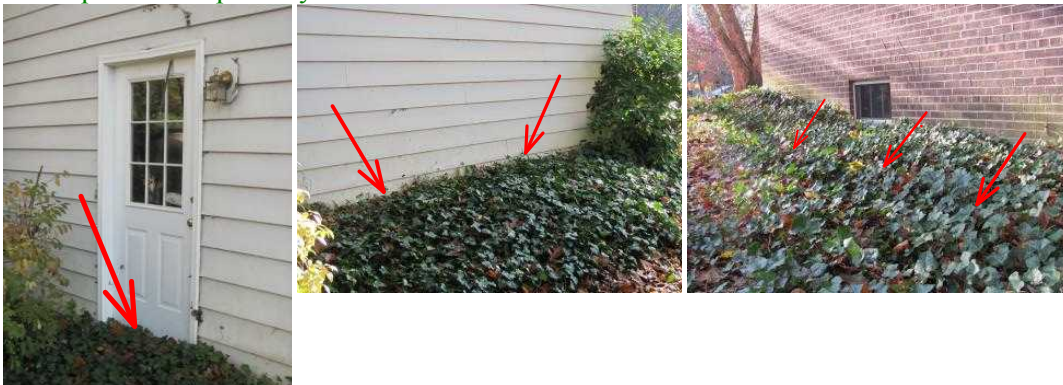
6. Grading: Negative slope, Flat drainage around house foundation - The ground around the foundation has settled in many areas resulting in a flat or negative slope back towards the house foundation, which allows the ground to become saturated with water or even pool water too close to the foundation walls.

Protect the basement from leaking and flooding by creating positive slope away from the house for at least 8 to 10 feet at all sides of the foundation. The minimum ground slope should be 1/2 inch of slope for every foot away from the foundation, so the yard 10 feet away from the house should be at least 5 inches lower than the ground at the foundation.

Fill in any voids in the ground around the front porch concrete slab.

Remove all ivy and soil on the side of the garage so that it is at least 4 to 6 inches below the wood framing in the side wall of the garage.

A basement window well may need to be install on the right side of the house to raise the grade enough to create positive slope away from the foundation.

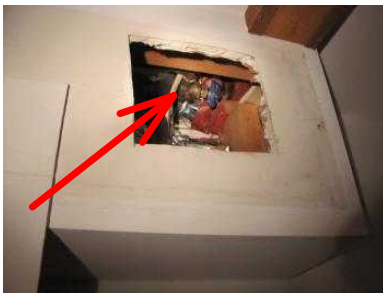
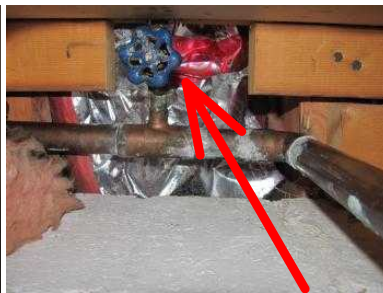
8. Hose Bibs: **The front hose bib shut off valve located above the main water shut off valve, is leaking, repairs are necessary.**

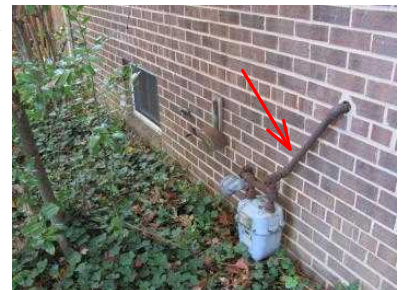
9. Gas Meter: **Paint the pipes by the rear gas meter to prevent further corrosion of the pipes.**

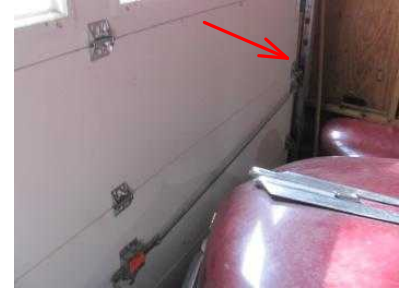
Adjust the door locking mechanism so the garage interior can be secured.

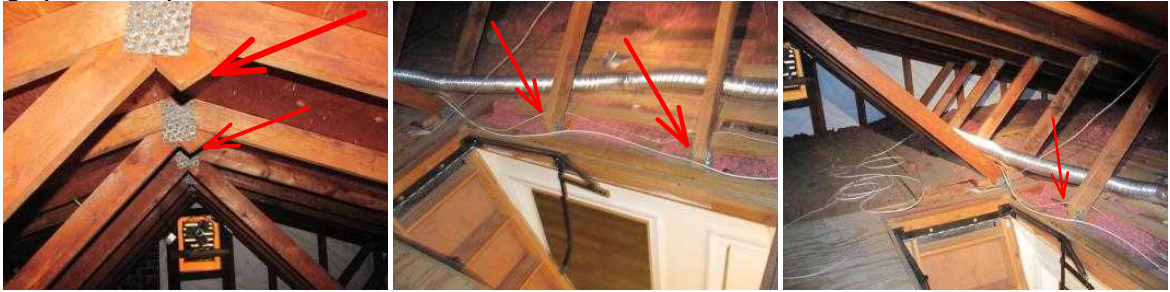
Recommend reinforcing the the two roof trusses where the support members were remove to make head room for the attic stairs.

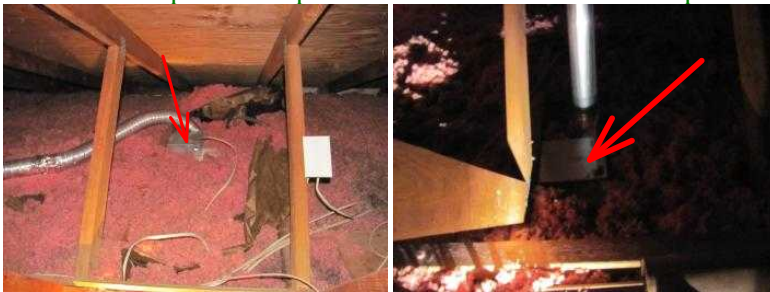
5. Insulation: The attic insulation is only 3.5 inches thick.

Recommend removing the attic floor plywood and adding 10 to 12 inches of blown in fiber glass insulation.

Insulate the top of the exposed bath room exhaust fans to prevent condensation during the winter.

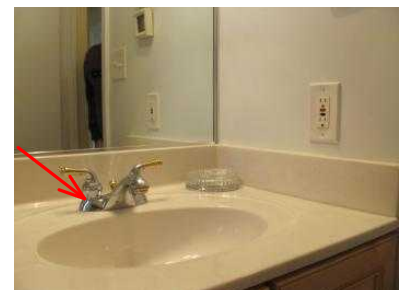
7. Electrical: GFI outlet present.
8. Sink, Basin, Cabinet: **Secure the loose sink faucet.**

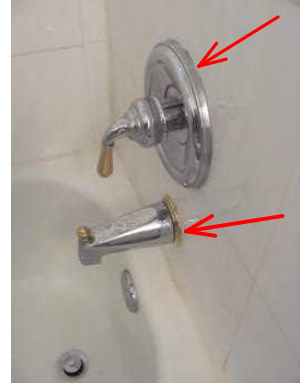
9. Tub, Surround: **Caulk the joint between the tub spout and the wall tile, and the faucet trim and the wall tile.**

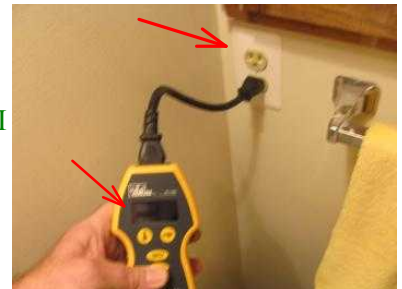
Have a licensed electrician repair the basement bath room outlet and the GFI breaker in the electric panel.

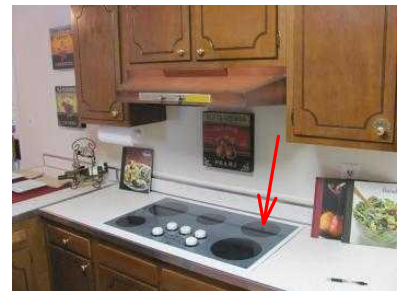
1. Range, Stove, Oven: electric cook top with single wall oven - The rear right electric burner has a chip in the glass cook top
2. Ventilator: Recirculating fan, not vented to the exterior. The hood fan motor has a long delayed start.

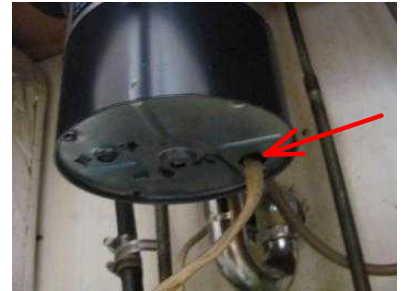
3. Garbage Disposal: Install a wire connector or clamp on the disposal electric supply wire.

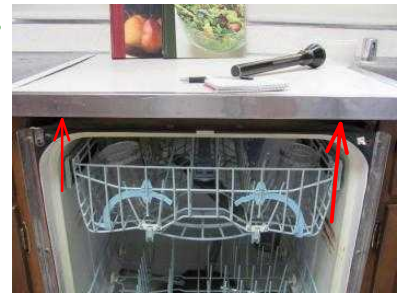
4. Dishwasher: Secure the dishwasher to the counter top with the anchor straps provided at the top of the dishwasher.

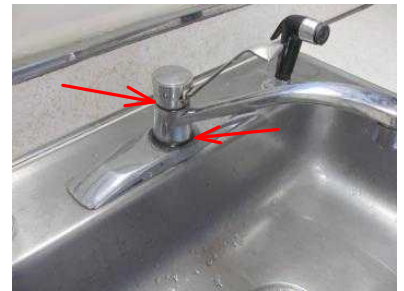
7. Kitchen Sink: The kitchen sink faucet is leaking at the spout and the handle.

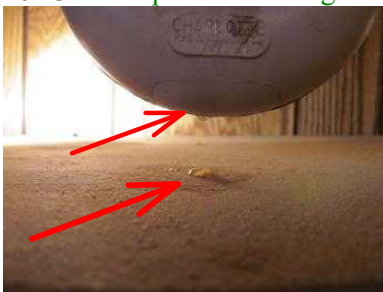
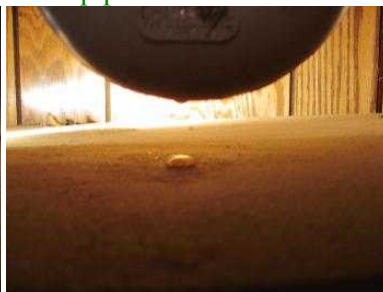
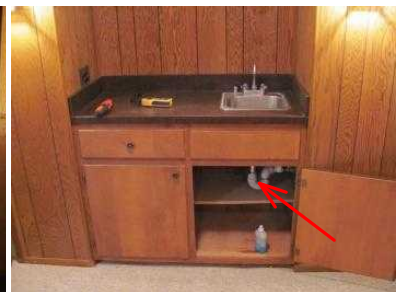
8. Bar Sink: Repair the leaking sink drain pipe below the basement bar sink.

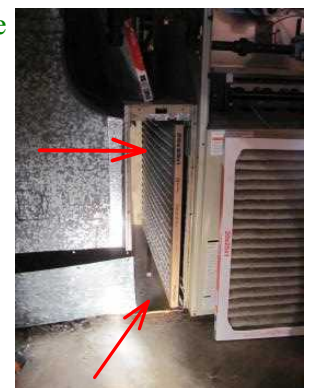
7. Blower Fan, Filter: **Install a track for the furnace filter and a sliding cover that can be quickly removed to change the filter, presently about 10 to 12 screws have to be removed from the cover and the filter fits loosely in the return duct.**

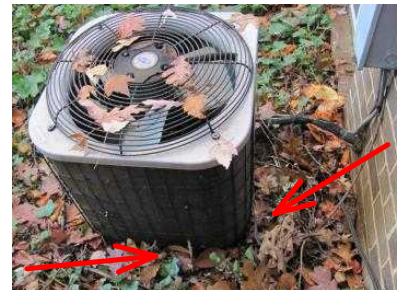
1. A/C System Operation: To avoid possible compressor damage due to outside temperature below 60 degrees, the air conditioning unit was not tested.
2. Condensate Removal:
3. Exterior Unit: Remove the ivy, sticks ,leaves, and other debris from around the bottom of the exterior compressor unit.

The air conditioning compressor is near the end of it's designed service life.

Plan and budget to replace the air conditioning compressor.

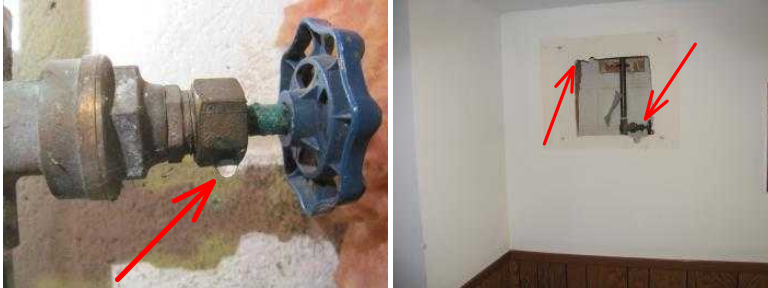
| 2. | <input type="checkbox"/> | <input checked="" type="checkbox"/> | <input type="checkbox"/> | <input type="checkbox"/> | Main Water Shutoff: Repair the leak at the main water shut off valve. |

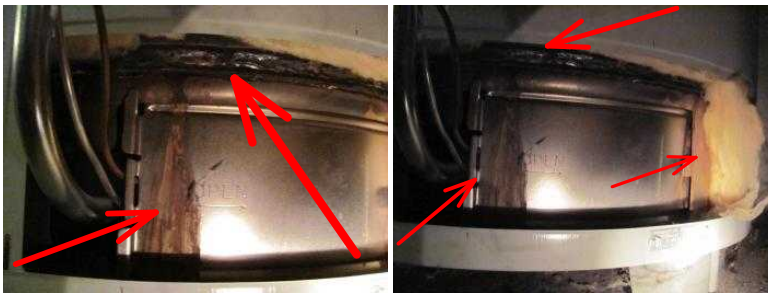
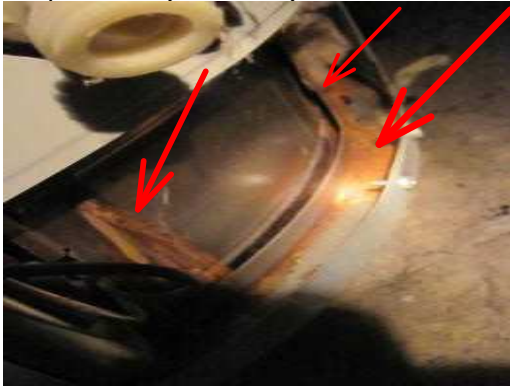
| 8. | <input type="checkbox"/> | <input checked="" type="checkbox"/> | <input type="checkbox"/> | <input type="checkbox"/> | Water Heater Operation: Functional at time of inspection - The water heater has corrosion and rust stains behind the gas burner cover. The water heater was not leaking at this time of the inspection. |

The heater is 13 years old, and given the corrosion already present, you should budget and plan for the replacement of the water heater.

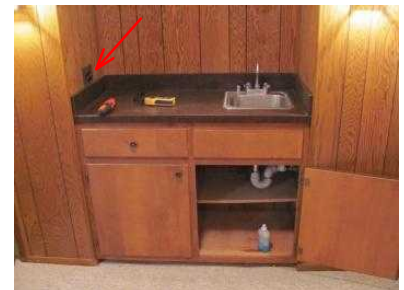
1. Approximate Height: 7.5 feet
2. Ceiling:
3. Walls:
4. Floor:
5. Floor Drain:
6. Doors:
7. Windows: **Basement windows need putty and paint on the exterior.**
8. Electrical: **Recommend installing an GFI outlet next to the basement bar sink.**

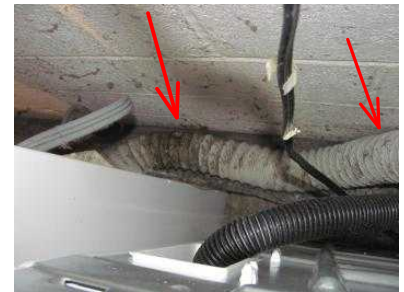
3. Clothes Washer:
4. Clothes Dryer:
5. Dryer Vent: Recommend installing a metal flexible dryer vent pipe to replace the plastic dryer vent.

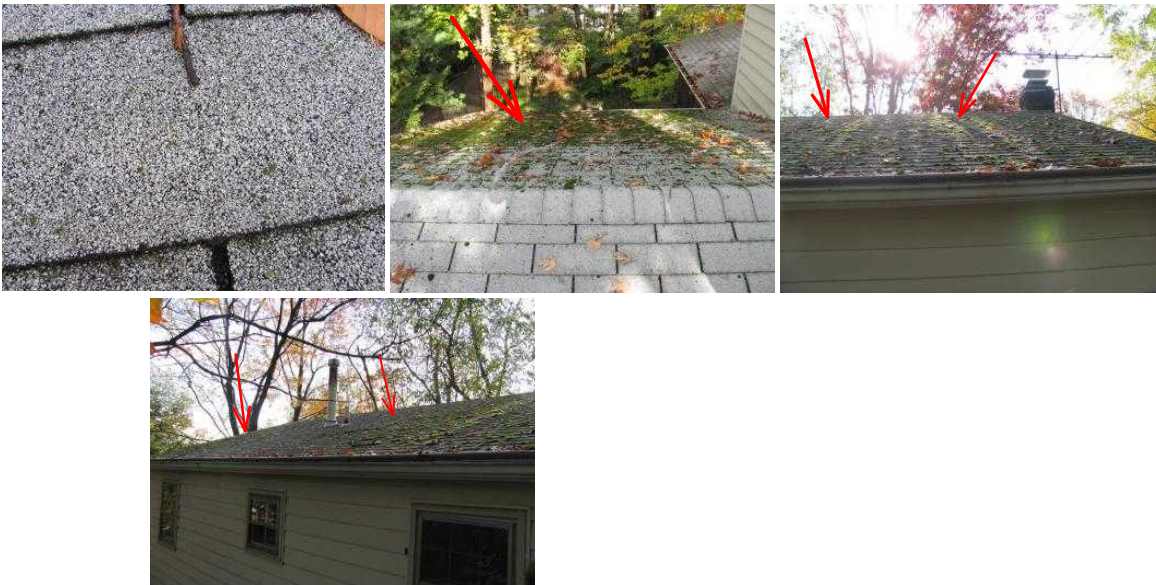
1. Roof Surface Material: Asphalt shingle - The roof shingles are worn and losing their granular surface.

The roof shingles are near the end of their useful service life, plan and budget for roof shingle replacement in the next 2 to 3 years.

Consider installing ridge vent and a larger roof mounted attic fan when replacing the roof shingles.

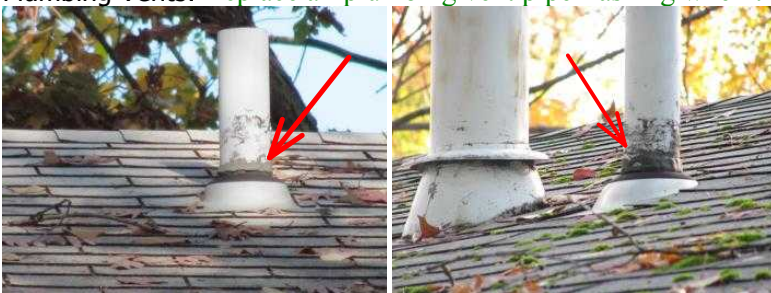
2. Plumbing Vents: Replace all plumbing vent pipe flashing when the roof shingles are replaced.

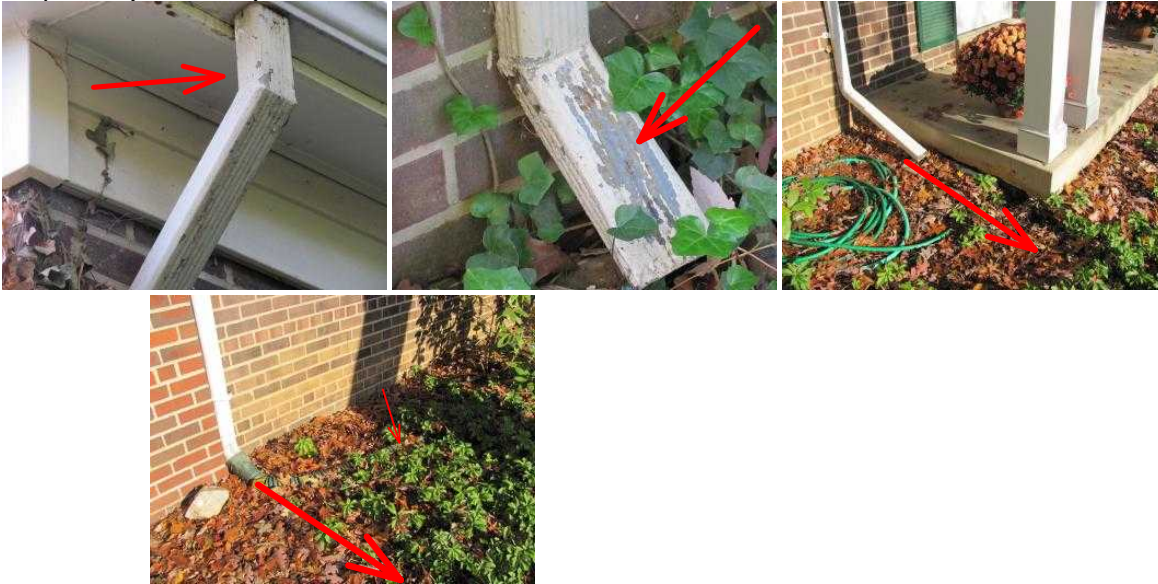
4. Downspouts: Aluminum, Galvanized - The lower roof gutters have some older galvanized downspouts that will need to be painted or replaced.

Extend front left downspout from the main roof at least 6 feet away from the house foundation.

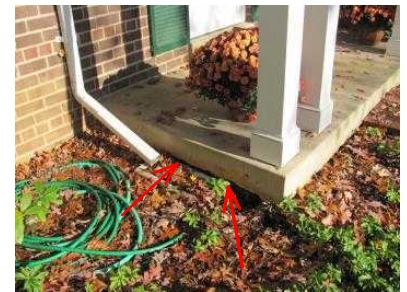
5. Walks: Stepping stones - The stepping stone walkway and the steps to the front porch are unevenly spaced and a trip hazard.
Recommend a wider, permanent walk way and steps all the same height to the porch.
6. Steps, Stoops: Replace the front steps to the entry porch, the steps should all be the same height.

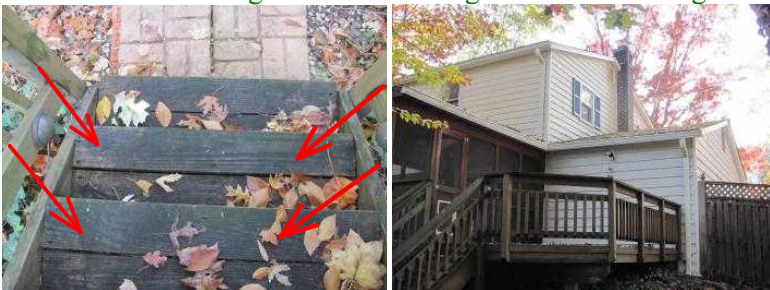
7. Deck: Pressure Treated wood - The rear deck stairs to the back yard have a loose stair tread near the ground level, this is a trip hazard.

Recommend cleaning the wood decking boards and sealing or staining the all wood surfaces.

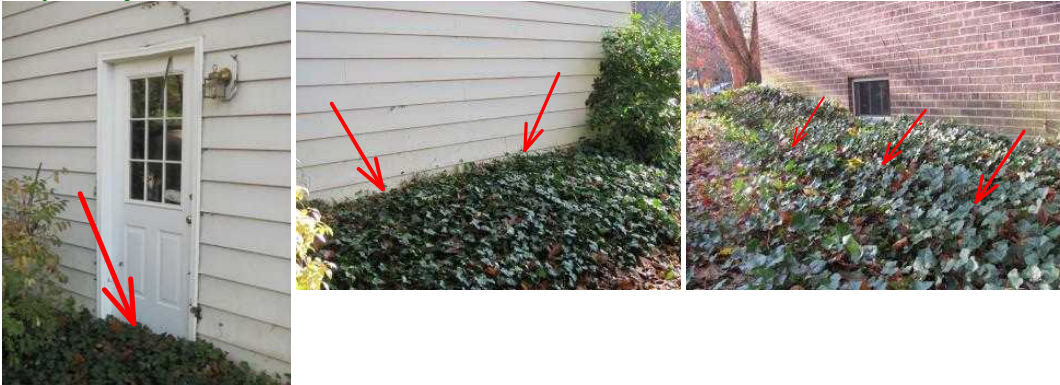
8. Grading: Negative slope, Flat drainage around house foundation - The ground around the foundation has settled in many areas resulting in a flat or negative slope back towards the house foundation, which allows the ground to become saturated with water or even pool water too close to the foundation walls.

Protect the basement from leaking and flooding by creating positive slope away from the house for at least 8 to 10 feet at all sides of the foundation. The minimum ground slope should be 1/2 inch of slope for every foot away from the foundation, so the yard 10 feet away from the house should be at least 5 inches lower than the ground at the foundation.

A basement window well may need to be install on the right side of the house to raise the grade enough to create positive slope away from the foundation.

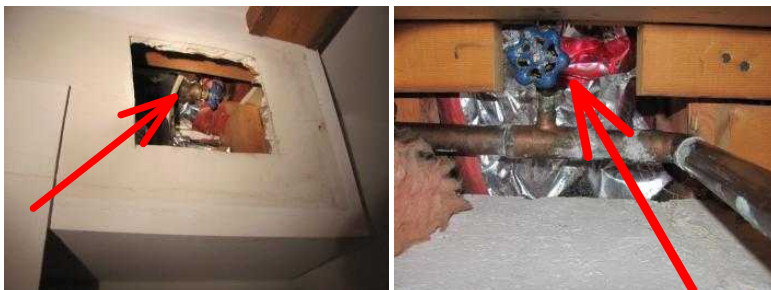
12. **Hose Bibs:** The front hose bib shut off valve located above the main water shut off valve, is leaking, repairs are necessary.

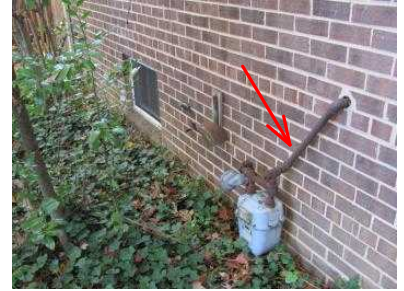
13. Gas Meter: Paint the pipes by the rear gas meter to prevent further corrosion of the pipes.

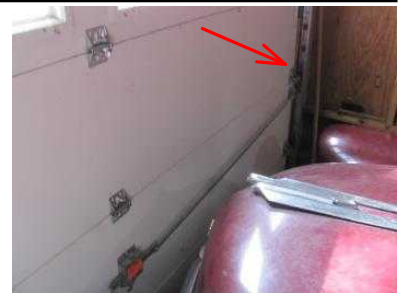
14. Garage Garage Doors: The over head garage door is manually operated.
Adjust the door locking mechanism so the garage interior can be secured.

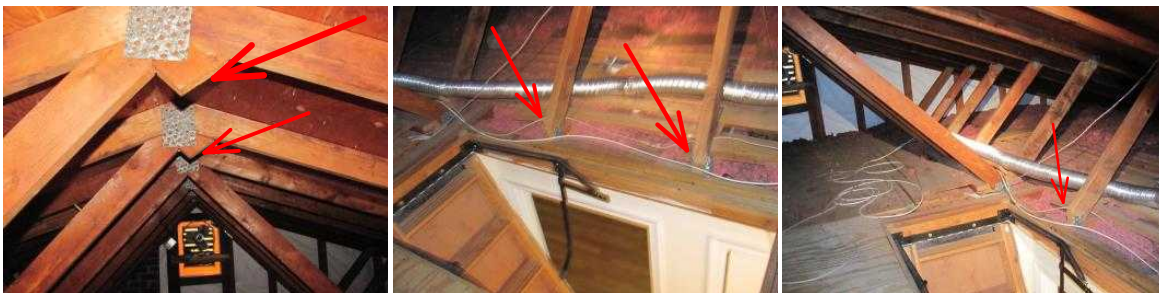
Recommend reinforcing the the two roof trusses where the support members were remove to make head room for the attic stairs.

Roof trusses are engineered structural members, and they are not designed for attic storage loads.

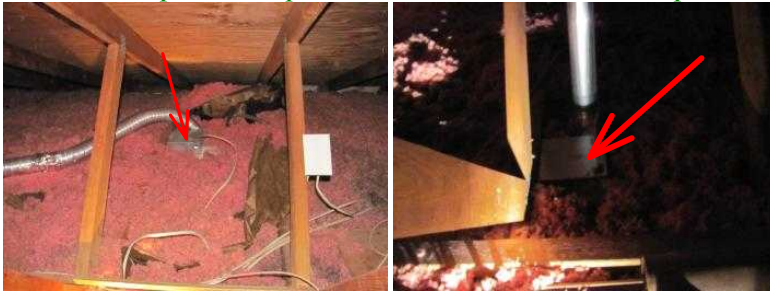
Recommend removing the attic floor plywood and adding 10 to 12 inches of blown in fiber glass insulation.

Insulate the top of the exposed bath room exhaust fans to prevent condensation during the winter.

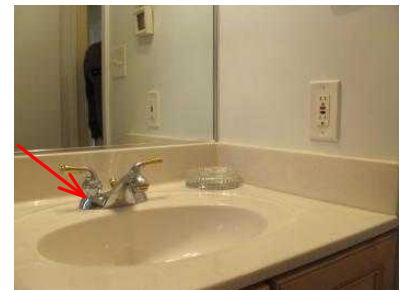
25. Hall Bathroom Sink, Basin, Cabinet: Secure the loose sink faucet.

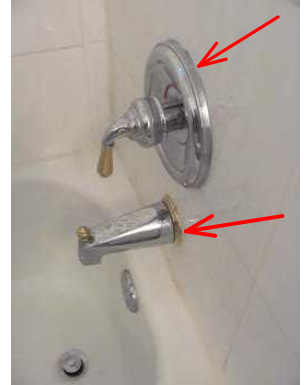
26. Hall Bathroom Tub, Surround: Caulk the joint between the tub spout and the wall tile, and the faucet trim and the wall tile.

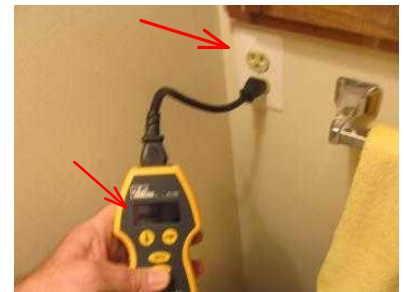
27. Hall Bathroom Toilets: Adjust the water refill valve in the toilet tank.
28. Powder room Bathroom Toilets: Adjust the water refill valve in the toilet tank.
29. Basement powder room Bathroom Electrical: The GFI breaker for the basement bathroom outlet continues to trip if reset.

Have a licensed electrician repair the basement bath room outlet and the GFI breaker in the electric panel.

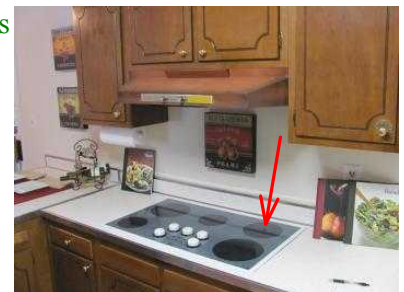
32. Kitchen Range, Stove, Oven: electric cook top with single wall oven - The rear right electric burner has a chip in the glass cook top
33. Kitchen Ventilator: Recirculating fan, not vented to the exterior. The hood fan motor has a long delayed start.

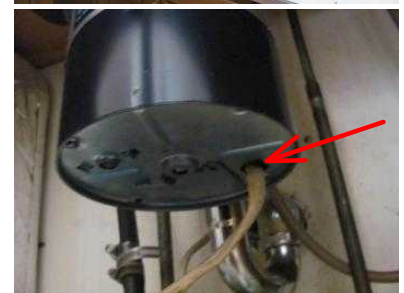
34. Kitchen Garbage Disposal: Install a wire connector or clamp on the disposal electric supply wire.

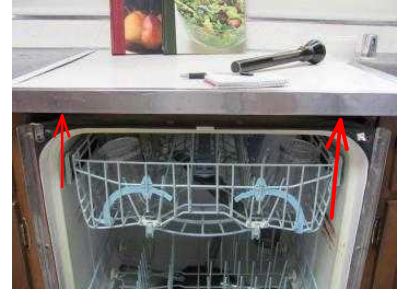
35. Kitchen Dishwasher: Secure the dishwasher to the counter top with the anchor straps provided at the top of the dishwasher.

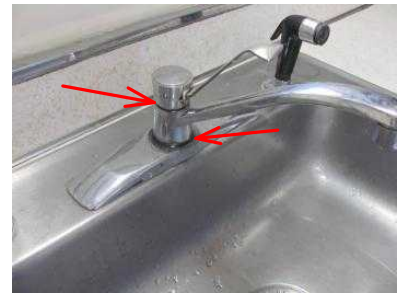
36. Kitchen Kitchen Sink: The kitchen sink faucet is leaking at the spout and the handle.

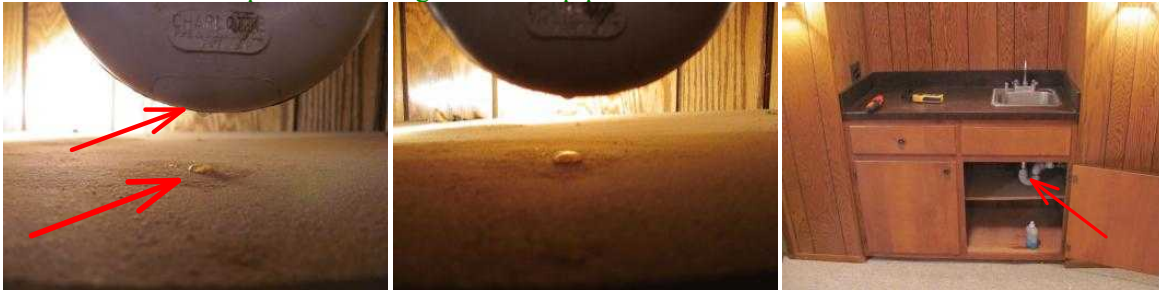
37. Kitchen Bar Sink: Repair the leaking sink drain pipe below the basement bar sink.

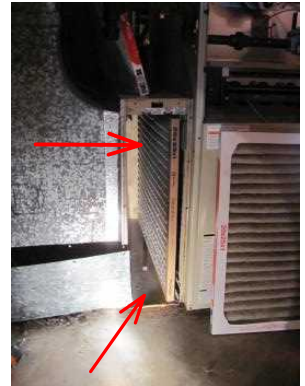
41. Basement utility room Heating System Blower Fan, Filter: **Install a track for the furnace filter and a sliding cover that can be quickly removed to change the filter, presently about 10 to 12 screws have to be removed from the cover and the filter fits loosely in the return duct.**

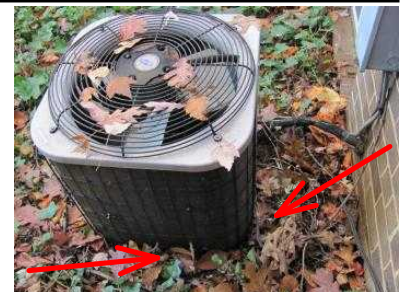
The air conditioning compressor is near the end of it's designed service life.

Plan and budget to replace the air conditioning compressor.

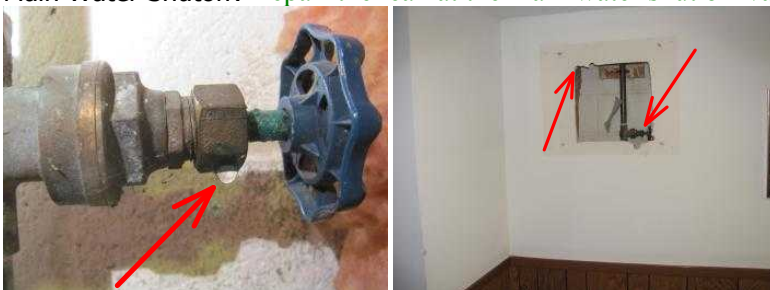
44. Main Water Shutoff: **Repair the leak at the main water shut off valve.**

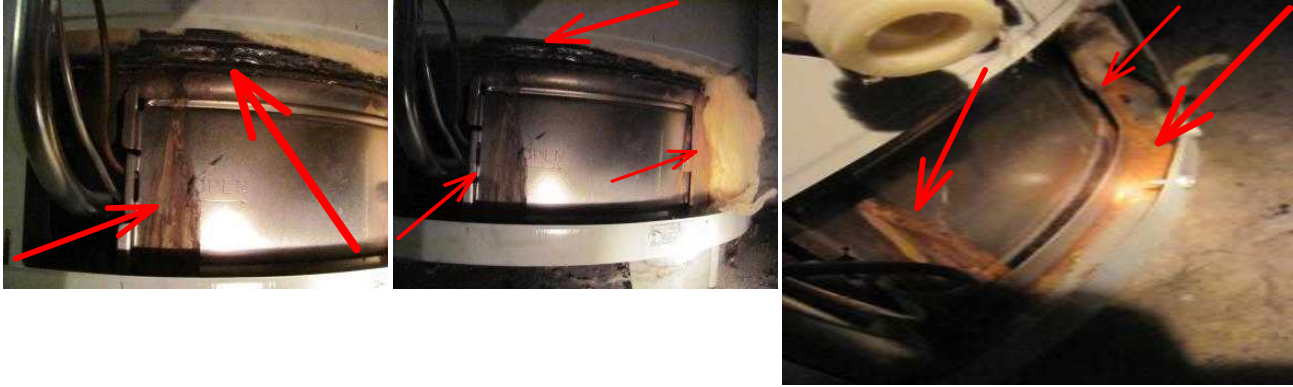
45. Basement Water Heater Water Heater Operation: **Functional at time of inspection - The water heater has corrosion and rust stains behind the gas burner cover. The water heater was not leaking at this time of the inspection.**

The heater is 13 years old, and given the corrosion already present, you should budget and plan for the replacement of the water heater.

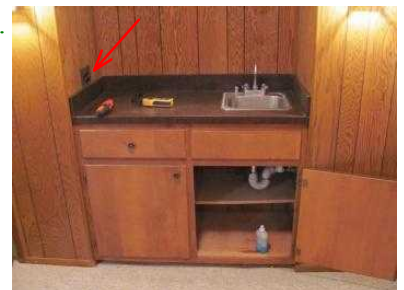
49. Basement Electrical: **Recommend installing an GFI outlet next to the basement bar sink.**

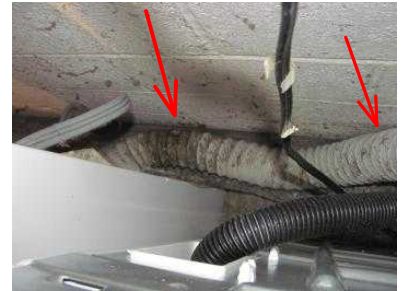
51. Laundry Room/Area Dryer Vent: Recommend installing a metal flexible dryer vent pipe to replace the plastic dryer vent.
