Property Inspection Report

44444 Anywhere Avenue
Springfield, VA 22152

General Information

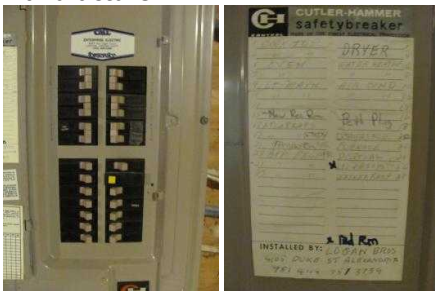
Basement Electric Panel

9. Manufacturer: Cutler-Hammer

10. Maximum Capacity: 150 AMPS
11. Main Breaker Size: No single main breaker exists
12. Breakers:

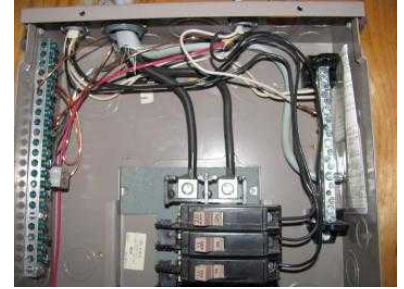
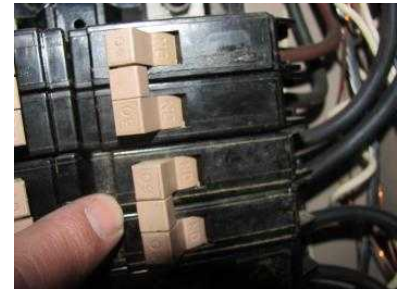
15. Manufacturer: Cutler-Hammer

16. Maximum Capacity: 125 Amps

17. Main Breaker Size: 60 Amps

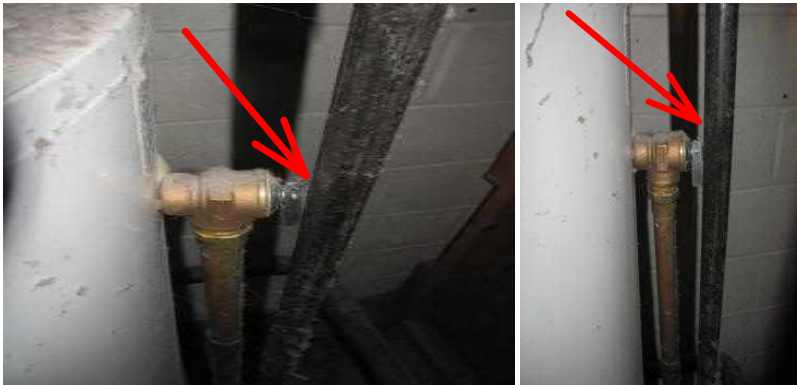
- 9. Manufacturer: Bradford-White
- 10. Type: Natural gas Capacity: 50 Gal.
- 11. Approximate Age: NOVEMBER, 1997 Area Served: Whole building
- 12. Flue Pipe:
- 13. TPRV and Drain Tube:

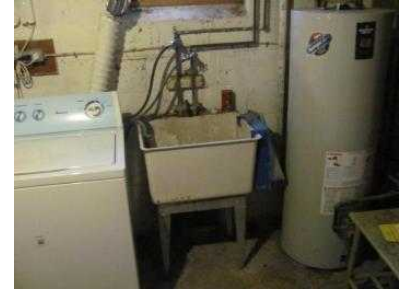
3. Clothes Washer:
4. Clothes Dryer:
5. Dryer Vent: Recommend installing a metal flexible dryer vent pipe to replace the plastic dryer vent.
